IMPORTANT FITTING INFORMATION

Accumulator

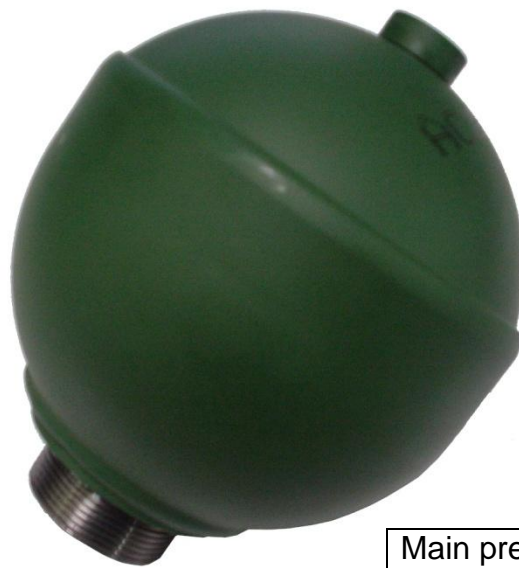
Main pressure
accumulator

Check the main accumulator functions correctly before replacing the steering pump.

A faulty accumulator places heavy strain on the hydraulic pump causing it to leak.

A faulty accumulator can often be identified by a fast ticking noise and must be replaced in order to ensure the longevity of the pump.

Most pumps are replaced as a result of faulty accumulator and therefore we strongly recommend changing the accumulator when replacing the pump.
